# 2011 Annual Monitoring Inspection Report

- Land Conservation Investment Program -

Town: Amherst  
Grantor / Acres: Arnold / 88.9 + 30.1 = 119 (both tracts reported)  
(ACC does not distinguish between the two lots)  
Fee (F) or Easement (CE): F  
Local Property Name: Joe English / Arnold Land  
Tax Map / Lot:

Town: Amherst  
Grantor / Acres: Scott / 41.69  
Fee (F) or Easement (CE): F  
Local Property Name: Soughan Canoe Port  
Tax Map / Lot: 4/48 + 2/140

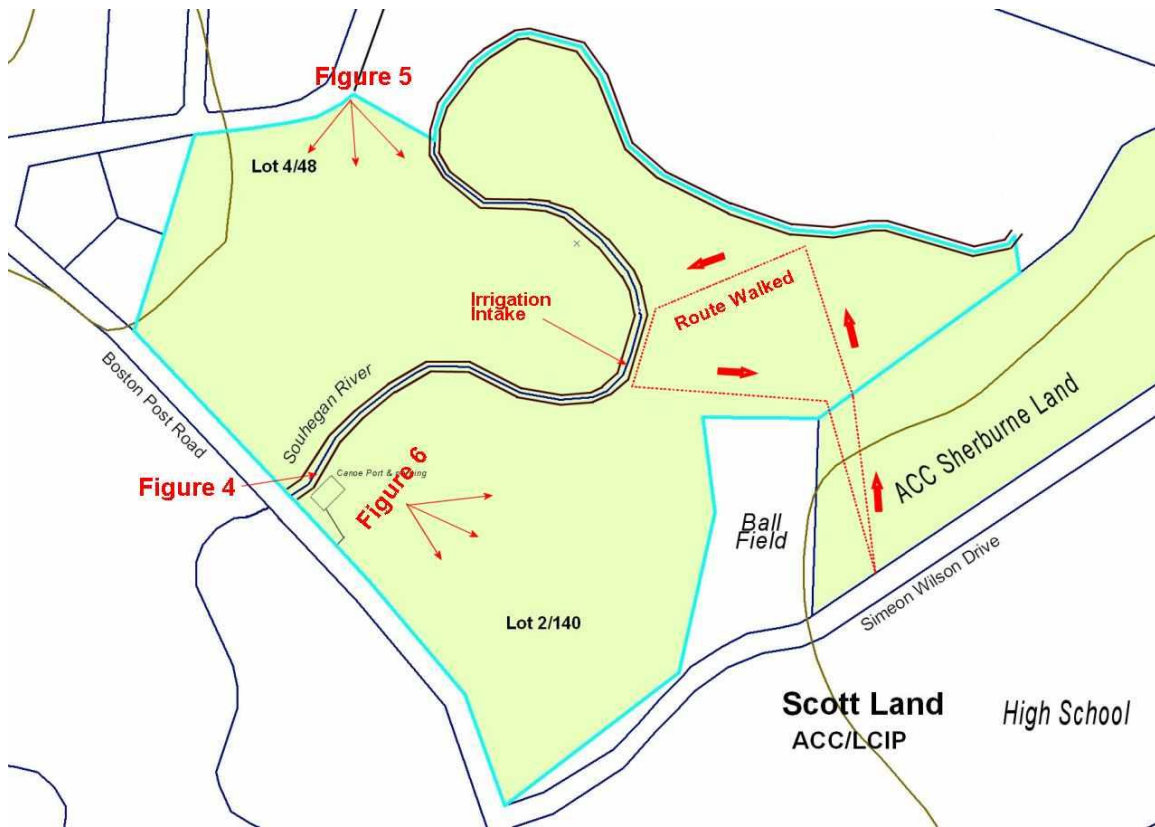
Figure 4 shows the only remedial action required – apparently high waters have raised the west side of one of the Canoe Port stairways and have carried off the handrail from that stair. For once the treads on both stairs appear intact. Repairs may take place yet this year, but the peak usage of the Canoe Port is in spring and summer.

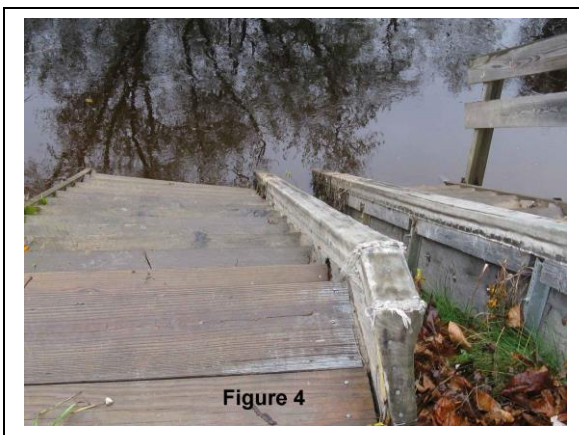
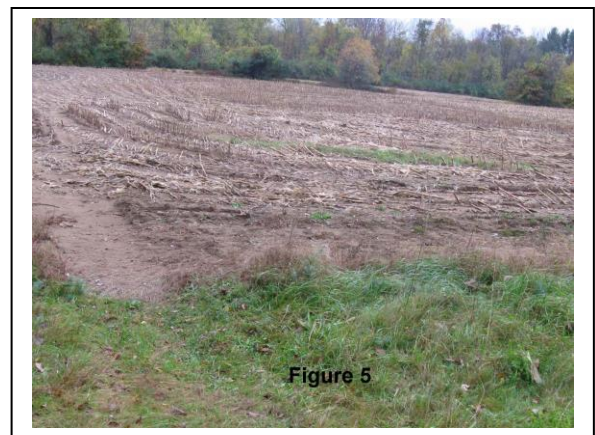
Figures 5 and 6 illustrate the residue from this year's successful agricultural operations. The farmer who raised corn this year and last has contributed to fertilizing both fields and intends in the future to raise alfalfa here.
